Time Dependent Early Breakdown of AlGaIn/GaN Epi Stacks and Shift in SOA Boundary of HEMTs Under Fast Cyclic Transient Stress

Bhawani Shankar¹, Ankit Soni¹, Sayak Dutta Gupta¹, Swati Shikha¹, Sandeep Singh¹,
Srinivasan Raghavan² and Mayank Shrivastava¹

¹Department of Electronic Systems Engineering and ²Center for Nanoscience and Engineering,
Indian Institute of Science, Bangalore, India, email: mayank@iisc.ac.in

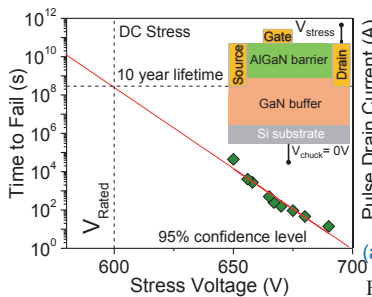
Fig. 1. Time-to-fail (TTF) for the commercially available 600V AlGaIn/GaN stack (used in this work) demonstrating 10-year lifetime for 600V dc stress.

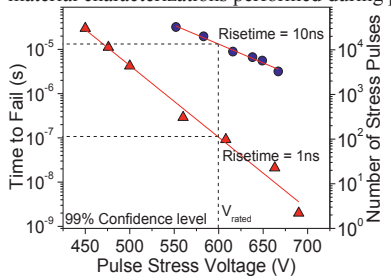
Time to Vertical Breakdown under Pulse Stress: Time to fail (TTF) extracted using fast transient cyclic pulse stress shows exponential dependence on applied stress voltage (Fig. 5) however the TTF was found to be much smaller compared to the same under DC stress case. For instance, 600V GaN Epi-stack qualified for 10-year lifetime under DC stress, failed after ~100 pulses, each being 500ns wide. Interestingly, TTF was found to improve when pulse rise time was increased, which indicates transient time dependent failure to be related to rate of change in electrical stress. Unlike under DC stress case (Fig. 6b), under cyclic pulse stress the vertical leakage with stress time remain unchanged till the verge of failure (Fig. 6a). Rapid and more severe changes in device characteristics are observed under pulse stress compared to that under dc condition (Fig. 7). Drain to substrate vertical leakage hysteresis was found to increase with stress time under pulse stress (Fig. 8), which points to charge trapping in different layers present between drain and substrate. PL mapping of drain-source region (Fig. 9) reveals increased defect generation introducing deep level traps within energy range of $E_c - 0.48$ eV and $E_c - 1.14$ eV. Highest PL intensity is observed near the drain contact (Fig. 9c). CL spectra (Fig. 10) taken at same location verifies increase in Blue (BL) and Yellow luminescence (YL) intensities with stress and penetration depth of ~1.2 μm from top surface. Hence, defects in GaN buffer are located close to 1.2 μm below surface in the drain contact vicinity. Raman map confirms mechanical stress builds up at the drain contact edge after the device is stressed for 5000 cycles under pulse condition (Fig. 11). Since AlGaIn is transparent to used visible (532 nm) laser, the stress signature received is from GaN buffer. This correlates well with penetration depth calculated from CL. Post failure cross-sectional SEM shows a catastrophic damage in GaN buffer, in vicinity of drain contact (Fig. 12). HR-TEM of defected region reveals fine cracks near GaN buffer and AlGaIn transition interface (Fig. 12). However, under DC stress, damage is localized to device surface and no failure signature is observed in the bulk.

Fig. 5. Time to fail (TTF) under pulse stress conditions presented on left y-axis and the corresponding number of pulses required for device failure at different voltages, shown on right side y-axis. Here pulse width of 500ns and OFF state period between two consecutive pulses are 100 μ s. Figure depicts, TTF is significantly lowered under pulse operation compared to that under dc and exhibits dependence on the rise time (slew rate) of the stress pulse.

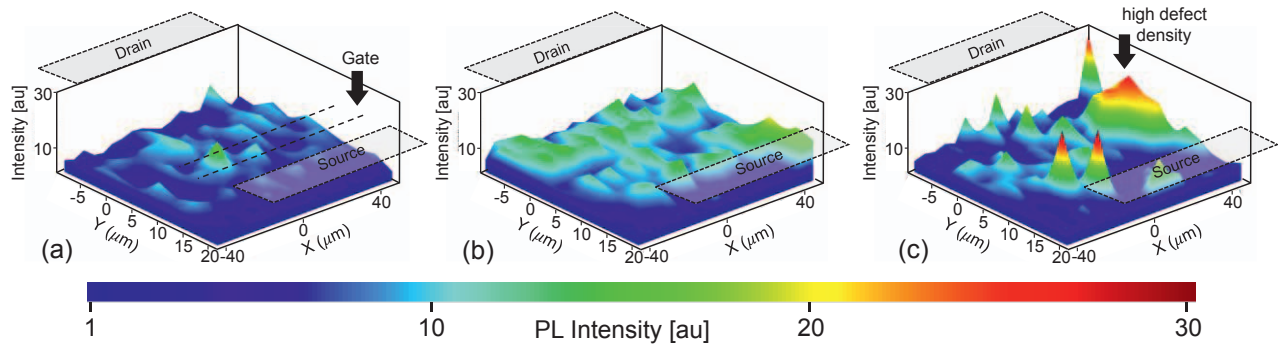
Fig. 9. PL intensity distribution for defect band (425-525nm) captured between source-drain region of the HEMT device (a) before stress, (b) after stressing with 5000 pulses and (c) at the verge of failure. Figure reveals that the density of mid-bandgap defects, increases with number of pulses (of 200V) with peak concentration close to drain contact edge.

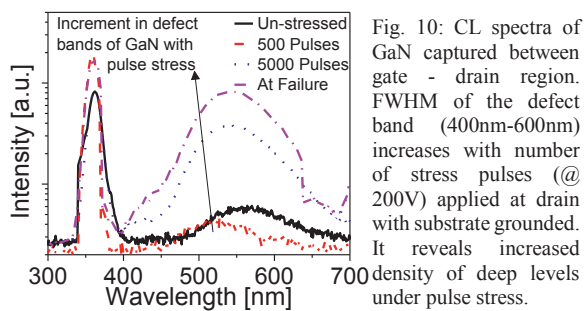
Fig. 10: CL spectra of GaN captured between gate - drain region. FWHM of the defect band (400nm-600nm) increases with number of stress pulses (@ 200V) applied at drain with substrate grounded. It reveals increased density of deep levels under pulse stress.

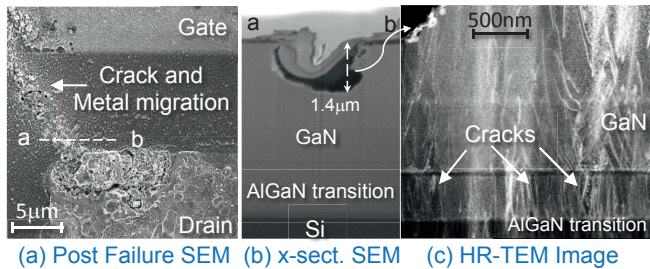
(a) Post Failure SEM (b) x-sect. SEM (c) HR-TEM Image

Fig. 12. (a) Top view SEM image depicting HEMT device failed under 600V pulse stress condition. Failure occurred with massive crack in the gate-drain region. (b) Cross-sectional SEM taken along line a-b reveals that the damage reached 1.4 micron deep into GaN buffer. (c) HR-TEM image of the region below damage area depicts cracking at the interface of GaN buffer/AlGaIn-transition region.

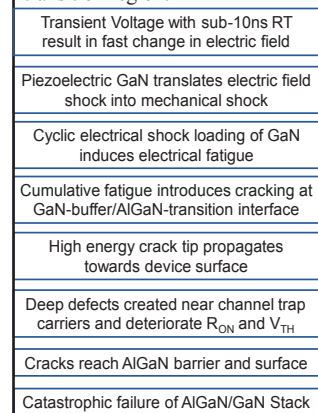
Fig. 15. The sequence of events which are responsible for Fast Transient Stress Assisted Time Dependent Breakdown and Shift in SOA Boundary of AlGaIn/GaN Epi Stacks & HEMTs.

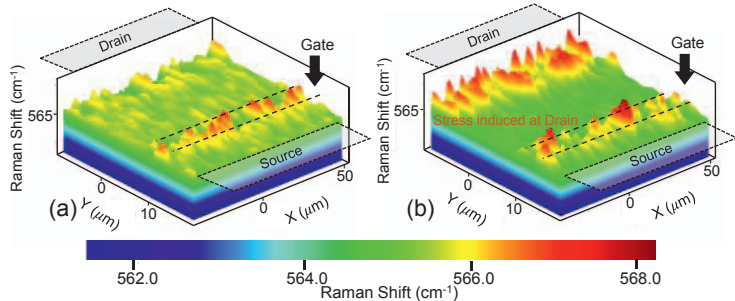
Fig. 11. (a) Raman map captured between source - drain region of pristine device, i.e. before applying stress. Figure reveals residual compressive stress in recessed region under gate. (b) Raman map of the device after application of 5000 stress pulses (@180V) between drain and substrate. Stress accumulation can be noticed near the drain contact edge, beside gate finger.

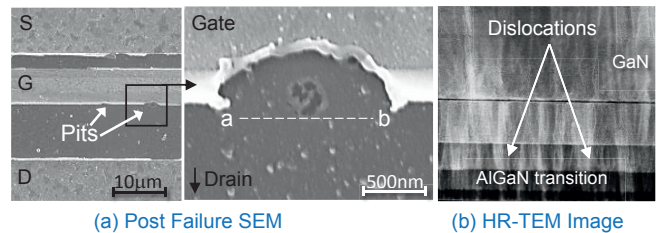
Fig. 13. (a) Top view SEM images of HEMT device failed after 600V of DC stress depicts shallow damage confined to top surface. (b) Cross-sectional TEM along a-b line shows no damage in bulk along dashed line 'a-b', reveals the failure occurred in device's active region close to AlGaIn/GaN interface at the top. No signature of bulk failure found. Similar localized failures observed in other dc stressed devices near top surface.

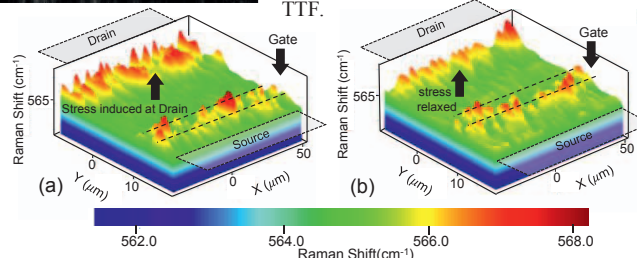
Fig. 16: (a) Post stress Raman map device stressed using 5000 pulses depicts stress accumulation around drain contact. (b) Relaxation in device stress, confirmed from Raman map captured, after the device was heated at 100°C for 10 mins post pulse stress

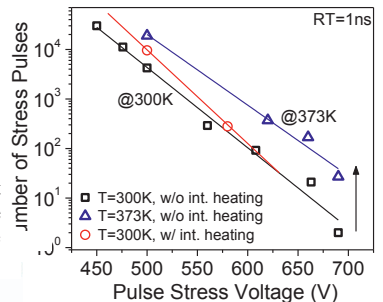
Validation of Proposed Failure Model: Stress accumulation and defect generation in GaN epi layers under pulse condition occurs due to electrical cyclic loading via compressive piezoelectric stress. Heating in device introduces thermoelastic tensile stress [16] which partially relaxes the field induced piezoelectric stress, as confirmed using Raman mapping (Fig. 16). This resulted in TTF improvement when stress applied at higher temperature or heat treatment was given in between cyclic stress (Fig. 17).

Fig. 17. Variation in vertical time-to-fail under pulse stress, recorded at different temperatures treatment. The increase in temperature, improves the TTF.
