First Observations on the Trap-Induced Avalanche Instability and Safe Operating Area Concerns in AlGaN/GaN HEMTs

Bhawani Shankar[®], Ankit Soni[®], Hareesh Chandrasekar[®], Srinivasan Raghavan, and Mayank Shrivastava[®], *Senior Member, IEEE*

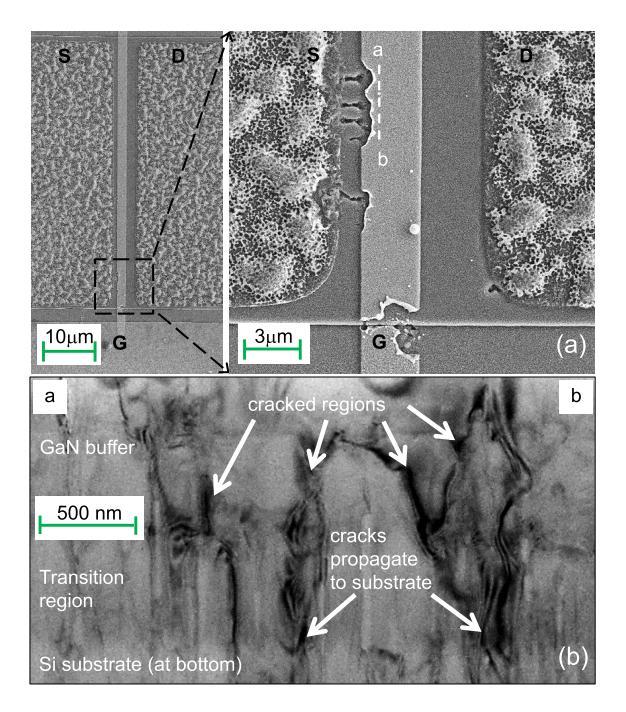
Fig. 12. (a) Postfailure SEM image of a device which failed under dark condition, when stressed using 10-ns wide pulses under OFF-state. It shows multiple damage sites in S-G region. (b) TEM cross-sectional taken along line "a-b" depicts cracks running deep into the buffer and transition regions.

Fig. 12(a) show the SEM image of a device which failed under dark condition in OFF-state. It reveals failure spots in the gate–source region. This is attributed to the accumulation of excess holes under the gate, which are generated from the enhanced II at drain due to trap-induced peak electric field shift as shown in Fig. 6. TEM cross section taken along the

damaged location in Fig. 12(a) unveils that the cracked sourcegate region runs deep into the buffer and reaches the transition region as clear from Fig. 12(b). This possibly results from the thermal stress generated due to the heavy current flow via localized parasitic conductive paths formed in buffer/transition region at breakdown, as learned from the TCAD study (Fig. 8) earlier. This observation corroborates well with the avalanche injection and filamentation theory presented in the previous section. Device failure under dark condition, stressed under ON-state condition, reveals gate-source failure with gate metal getting melted as shown in Fig. 13(a). The holes that are collected under the gate leak through the Schottky junction and increases the gate-source leakage [6]. Moreover, interface defects at Schottky gate increase under this stress [13]. Therefore, gate wears out/melts at the source side as clear from SEM image in Fig. 13(a). EDX analysis at damage location shows 9% Au which melted from gate region, as confirmed from SEM micrograph. Cross-sectional TEM of the dotted area from damaged source-gate region reveals Gallium out diffusion from GaN cap into Ni/Au Schottky gate. This is possibly due to the localized heating associated with high gate-source leakage.

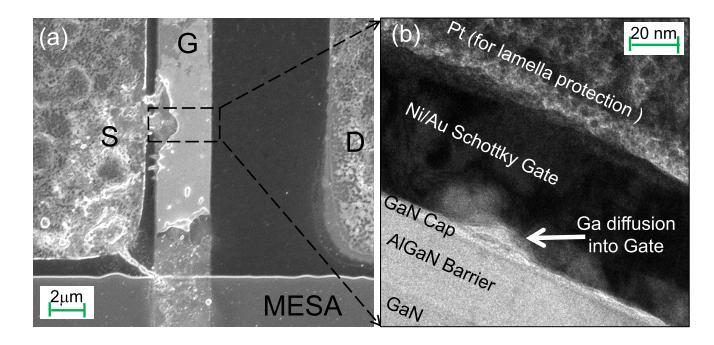
Fig. 13. (a) SEM image of HEMT with 11 μ m L_{SD} , which failed under dark condition when stressed with 10-ns-wide pulses under ON-state. (b) Cross-sectional TEM taken in the dotted area of the damaged S-G region reveals Gallium out diffusion from GaN cap into Ni/Au Schottky gate.

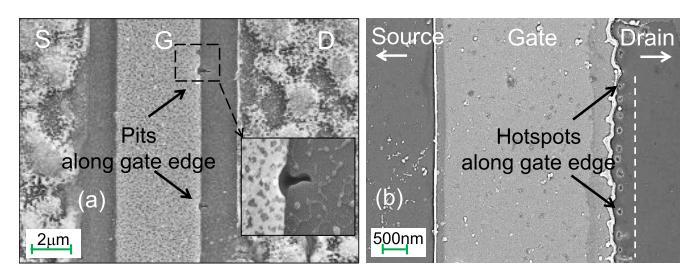
Postfailure SEM micrograph of devices which failed under UV condition in OFF-state is shown in Fig. 14(a). As clearly shown, pits originate at multiple locations along the gate edge toward drain. In devices as presented above, in the absence of traps, i.e., in the presence of UV light, the peak electric field lies at gate edge toward drain. The enhanced normal component of the peak field introduces mechanical strain at gate edge due to inverse piezoelectric field [21]. When the stored elastic energy hits a critical value, the mechanical stress relaxes by the formation of crystallographic defects/pits. Fig. 14(b) shows the SEM image of the device which failed while stressing device using 100-ns-wide pulse under UV exposure in ON-state condition. It reveals the signature of hotspots formed along the gate edge toward drain. As predicted from the TCAD study, in a device without traps, the electric field peak lies at drain side gate edge as shown in Fig. 6. This leads to the formation of hotspot at the gate edge toward drain as shown in Fig. 10, which can be distributed along the

Fig. 14. (a) SEM image of HEMT which failed at 100 ns under UV light in OFF-state condition. Pits get formed at multiple locations along the gate edge toward drain. (b) SEM image of HEMT with 7 μ m L_{SD} which failed at 100 ns under UV condition in ON-state. Images reveals continuously distributed hotspots along the gate edge toward drain. Gate metal folds up at hotspot locations. No damage is observed at source side.

device width as clear from Fig. 14(b). This leads to electrothermal instability and failure in the device. At lower PW, when the device is stressed for a shorter duration, the selfheating across the device naturally gets suppressed. As a result, the device sustains higher electric field and needs higher power to fail. Fig. 15(a) shows the SEM image of HEMT failed in ON-state under UV condition, stressed using 10-ns-wide pulses. It shows cracking in gate–drain region. The peak field and hotspot present at gate edge, generate stress in the vicinity of gate and leads to cracking of top AlGaN/GaN layers. Under the influence of gate–drain electric field, the crack propagates toward the drain as clear from cross-sectional SEM image of source/drain region shown in Fig. 15(b). Moreover, the hot spot under the gate peels-off gate metal as well.

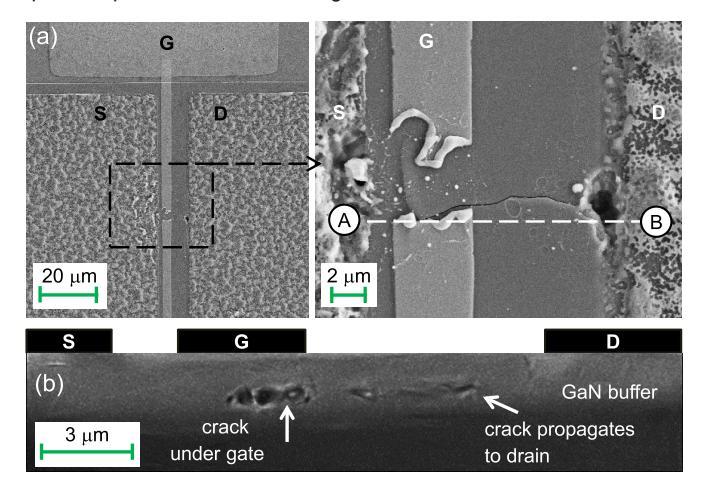
Fig. 15. (a) SEM image of HEMT failed under UV condition, stressed using 10-ns wide pulses depicting damage in G-D region. (b) Crosssectional SEM image taken along line "A-B" depicts cracks underneath the drain side of gate edge which propagated toward the drain.
