# Time Dependent Shift in SOA Boundary and Early Breakdown of Epi-Stack in AlGa<sub>N</sub>/Ga<sub>N</sub> HEMTs Under Fast Cyclic Transient Stress

**Abstract**—This experimental study reports first observations of (i) SOA boundary shift in AlGa<sub>N</sub>/Ga<sub>N</sub> HEMTs and (ii) early time-to-fail of vertical AlGa<sub>N</sub>/Ga<sub>N</sub> epi-stack under fast changing (sub-10ns rise time) cyclic pulse transient stress, which otherwise qualified for 600 V DC stress. It is shown that a epi stack qualified for 10 years lifetime under DC stress, fails faster under cyclic transient stress. The drain-to-substrate leakage exhibits different trends under DC and pulse stress. Integrated electrical and mechanical stress characterization routine involving Raman/ PL mapping, PFM and CL spectroscopy along with atomistic simulations reveals material limited unique failure physics under transient stress condition. Failure analysis using cross-sectional SEM and TEM investigations reveal signature of different degradation and failure mechanism under transient and DC stress conditions. A failure model is proposed for rapid breakdown of AlGa<sub>N</sub>/Ga<sub>N</sub> epi-stack under cycli

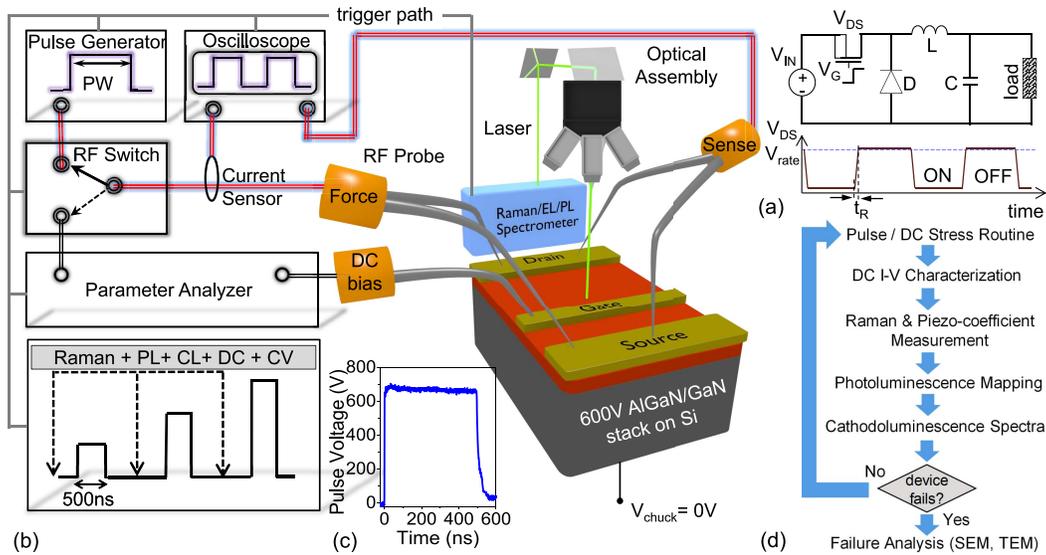
Fig. 1. (a) Schematic representation of buck power converter along with drain voltage ( $V_{DS}$ ) waveform during switching. (b) Schematic of experimental set-up with integrated Raman, PL and sub- $\mu$ s pulse generator used for on-the-fly electrical and material characterization of HEMT/epi-stack under stress. (c) Waveform of pulse stress voltage as applied at drain. (d) Flowchart depicting sequence of characterization steps performed during pulse and DC stress.

ALGAN/GAN HEMTs promise superior switching performance than their Si counterparts. However, their reliability, in particular, under switching conditions is less explored [1]. In a typical power converter, during OFF-cycle the high blocking voltage appears at drain, as shown later in Fig. 1(a) which introduces significant drain-to-gate lateral stress and enormous drain-to-substrate vertical stress. While the corresponding time dependent failure physics has been widely studied, but it is limited however to DC like stress [2]–[6]. For example, at low DC stress, drain-to-substrate

The experimental set-up used in this work is shown in Fig. 1(b). It was developed by integrating electrical, optical and material characterization techniques, which allows on-the-fly device-material co-study while device is under pulse cyclic and transient stress. The cyclic and transient stress, as encountered in a DC-DC buck converter, was emulated using rectangular pulses of a fixed pulse width (500 ns) as depicted in Fig. 1(c). Pulse rise time was varied in sub-10ns range, which is typical in GaN based power converters. An OFF period of 1 s was introduced between two consecutive pulses to allow reasonable time for the device to relax. Devices were also tested under constant DC stress to understand the difference in their degradation mechanisms under DC and pulse transient stress. To record the evolution of device degradation under stress, the electrical stress routine (DC or

pulse) was interrupted at regular intervals, in each case and the change in electrical as well as material parameters of the device was recorded. Following measurements were carried out to monitor changes in parameters: (i) drain-to-substrate vertical leakage current was measured after each stress pulse and its hysteresis behaviour was recorded at regular intervals. (ii) Device's DC characteristics were measured and change in its ON-resistance ( $R_{ON}$ ), ON-current ( $I_{ON}$ ) and threshold voltage ( $V_{TH}$ ) was determined at regular intervals. In region between source and drain (iii)  $\mu$ -Raman mapping was done to record change in piezoelectric strain distribution, (iv) UV-Photoluminescence (PL) mapping is done to capture newly formed trap levels and their corresponding spatial distribution. (v) Cathodoluminescence (CL) spectra was measured in regions which showed high PL intensity of blue and yellow luminescence defect bands, at different stress time. CL depth profiling [12] was done to determine the exact location of defected regions within the epitaxial stack. At high e-field, mechanical stress generates across the active region of device due to the piezoelectric nature of GaN. The evolution of mechanical stress distribution was captured using visible Raman ( $\lambda = 532$  nm) where, a positive shift in GaN's  $E_{2H}$  peak ( $567.5$   $\text{cm}^{-1}$ ) indicates compressive strain whereas a negative shift points to tensile strain in GaN devices [13]. The defects density distribution was determined using PL with UV ( $\lambda = 325$  nm) excitation from a He-Cd laser. After device failure SEM and TEM analysis was done to gain physical insight into the breakdown mechanism. The characterization routine as followed is summarized in the flowchart shown in Fig. 1(d).

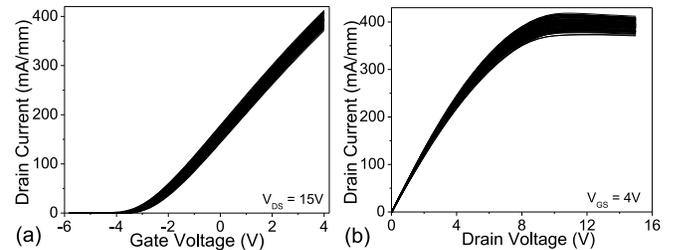
Fig. 2. DC (a) Transfer characteristics and (b) output characteristics of devices which were developed in-house on 600 V DC qualified AlGaIn/GaN epi-stack.

All the devices were surface passivated with 50 nm *in situ* SiN. 160 devices per die were fabricated and the processed run had more than 90% device yield with less than  $\pm$  5% variation. DC I-V characteristics of a set of in-house developed HEMTs are shown in Fig. 2. As evident from Fig. 2(a), the devices exhibit threshold voltage;  $V_{GS}$  of  $-3$  V and  $I_{ON}$  of  $\sim$ 375 mA/mm with less than  $\pm$  5% variation.

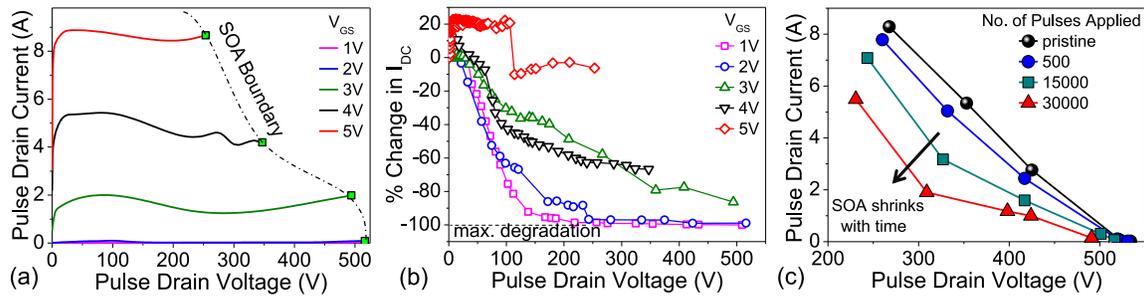
Fig. 3. (a) Pulse I-V characteristics depicting SOA boundary of a commercially available E-mode GaN HEMT. (b) Percentage change in linear drain-source current ( $I_{DC}$ ) measured after each voltage pulse. Device shows highest degradation in OFF state stress condition. (c) SOA of commercial e-mode GaN HEMT, extracted at different stages of OFF-state stress cycles. Shift in SOA boundary with increasing number of stress pulses can be seen.

To bench mark the observations, first the commercial E-mode GaN HEMT was characterized and its SOA boundary was extracted under pulse condition. Drain was pulsed with gate DC biased, while source and substrate were grounded. After each pulse, the drain-to-source linear current ( $I_{DC}$ ) was spot measured (at 1 V DC) immediately after the pulse goes OFF, to record change, if any, due to the applied stress. For each gate bias,  $V_{DS}$  was increased in step size of 1 V, till the device's breakdown point, which marked the SOA boundary. Figure 3(a) shows the measured pulse I-V characteristics of the device, depicting its SOA boundary.  $I_{DC}$  decreased with increase in pulse drain voltage as seen in Fig. 3(b), which is due to trapping induced degradation [1]. A maximum degradation of up to  $\sim 100\%$  was observed under OFF-state whereas a relatively lower change in  $I_{DC}$  was seen in ON-state. These observations highlight that the OFF-state stress is the worst-case scenario for device. During the OFF-state, maximum voltage stress appears from drain-to-substrate along with drain-to-gate. This high stress condition occurs periodically during the OFF-cycle of the power converter as illustrated in Fig. 1(a). Therefore, this work hereafter focuses on drain-to-substrate cyclic pulse stress in AlGaIn/GaN HEMT and its implications on device's SOA and reliability.

Each time, a set of five devices was pre-stressed at 180 V for a certain number of pulses. After the stress, the corresponding SOA boundary was determined. The number of pulse stress cycles was increased in the subsequent device sets. Figure 3(c) shows device's SOA boundary extracted under increasing number of pulses from 0 (which refers to the pristine device) to 30000. A shift in SOA boundary is observed under cyclic pulse stress. SOA shrinks with increase in number of stress cycles of fixed amplitude. This is unusual as such a SOA shift does not exist in conventional Si power devices and was never explored earlier for AlGaIn/GaN HEMT. Such unwanted shift in SOA boundary with time, during the switching operation can impose serious reliability challenge to GaN HEMTs in power switching applications. Hence, it is crucial to understand the underlying physics of SOA degradation.

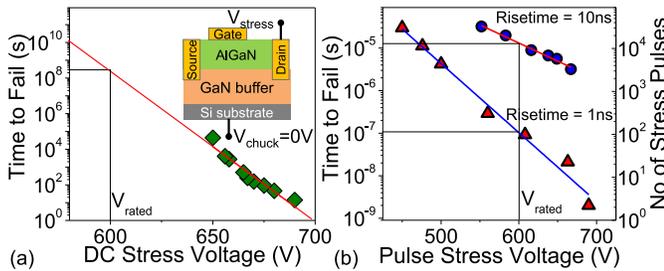
Fig. 4. (a) Time-to-fail (TTF) for the AlGaIn/GaN epi-stack used in this work demonstrating 10-year lifetime for 600 V DC stress. (b) TTF under pulse stress is presented on left y-axis and the corresponding number of pulses required for epi-stack failure is shown on right y-axis.

Next, voltage pulses of a fixed amplitude, each of 500 ns pulse width and 1 ns rise time, were applied on the AlGaIn/GaN epi-stack. The corresponding TTF is shown in Fig. 4(b). TTF shows exponential dependence on the applied pulse stress similar to that under DC stress, indicating electric field dependent failure. However, TTF was found to be much smaller than that under DC stress. For instance, the 600 V AlGaIn/GaN epi-stack which was qualified for 10-year lifetime under DC stress, failed only within 100 pulses. Further, the experiment was repeated with stress pulses of higher rise time. Interestingly, TTF was found to improve by two orders when pulse rise time was increased from 1 ns to 10 ns. This observation indicates that the time dependent rapid failure of AlGaIn/GaN epi-stack under pulse stress, is indeed also related to the rate of change of electrical stress or the slew rate ( $dV/dt$ ) of the applied stress pulse. The time evolution of  $I_{leak}$  under different pulse stress voltages is shown in Fig. 5(b). Unlike the DC stress case (Fig. 5a),  $I_{leak}$  remained intact over time under cyclic pulse stress, till the verge of epi-stack failure. On failure,  $I_{leak}$  increased abruptly beyond  $1 \mu A/mm$ , indicating a hard failure of AlGaIn/GaN epi-stack. Furthermore, just before failure  $I_{leak}$  turned noisy. Noise in leakage current originates from defect/trap generation in AlGaIn/GaN epi-stack [2] However, no noise was observed in leakage under DC stress as depicted in Fig. 5(a). To confirm the presence of trap generation in epi-stack under pulse stress, hysteresis in  $I_{leak}$  was studied. Figure 6 shows the change in hysteresis behavior of  $I_{leak}$  with increasing number of stress pulses/cycles. Pristine device showed negligible hysteresis as evident from insignificant loop

TTF, its dependence on pulse rise time (Fig. 4 b) and aggressive catastrophic failure of device (Fig. 11) under cyclic pulse transient stress. These newly discovered trends and findings in fact, suggest a presence of an electrical shock based fatigue phenomenon which is responsible for time dependent AlGaIn/GaN epi-stack failure under pulse stress. This can be explained as following; when a voltage pulse is applied across the AlGaIn/GaN epi-stack, vertical component of electric field ( $E_z$ ) introduces in-plane piezoelectric strain ( $\sigma_{xy}$ ) [15];

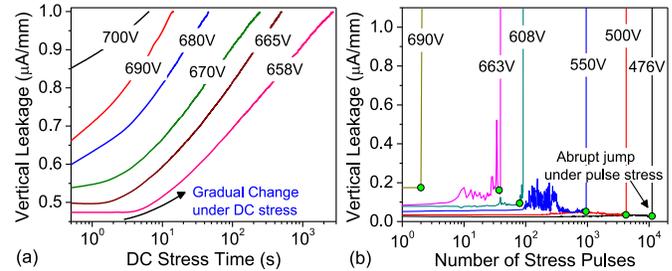
Fig. 5. Time evolution of drain-to-substrate vertical leakage current at different (a) DC stress voltages and (b) pulse voltages.

As, discussed in previous section, the drain-to-substrate pulse voltage, stresses the AlGaIn/GaN epi-stack in HEMT over the time, during power conversion. So, it is important to understand, the epi-stack degradation and its time dependent failure mechanism under pulse stress and understand how different it is from epi-stack failure under DC. To accomplish this, in-house developed HEMT was used. Lifetime of AlGaIn/GaN epi-stack in HEMT, was determined at different stress voltages, both under DC and pulse stress conditions. In each case, voltage stress was applied at drain while substrate was grounded. The drain-to-substrate leakage current ( $I_{leak}$ ) was continuously monitored during the stress.  $I_{leak}$  increased under stress. When it achieved 1  $\mu\text{A}/\text{mm}$  value, the epitaxial stack was considered failed. The corresponding time taken to fail the stack, is termed as time-to-fail (TTF). TTF of AlGaIn/GaN epi-stack varied with DC stress voltage as shown in Fig. 4(a). At 600 V DC stress, the stack shows a 10 year lifetime. An exponential dependence of TTF on applied stress voltage is observed which indicates electric field driven failure of AlGaIn/GaN epi-stack [6]. Under DC stress,  $I_{leak}$  increases gradually with time as shown in Fig. 5(a) and indicates soft-failure of AlGaIn/GaN epi-stack.

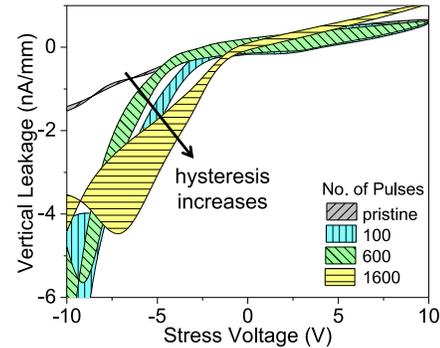
Fig. 6. Hysteresis behavior recorded in drain-to-substrate leakage current after different number of stress cycles applied at drain.

area of black curve in Fig. 6. However, a consistent increment in hysteresis area can be noticed with increase in number of stress cycles. This observation points to; (i) increased charge accumulation via trapping in different regions of bulk GaN with each stress pulse. Electrons trapped by deep-levels in buffer region, undergo slow de-trapping which leads to negative charge accumulation in epi-stack with increasing stress cycles. (ii) increased density of new defects in bulk GaN which further participate in electron trapping. Both these phenomena translate to increased hysteresis under pulse cyclic stress.

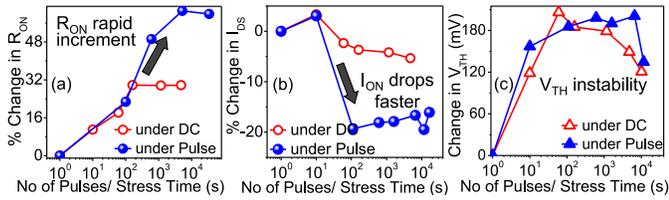
Fig. 7. Degradation in device parameters, recorded on-the-fly during DC and pulse stress measurements done at 180 V. (a)  $R_{ON}$  increases and (b)  $I_{ON}$  drops at a much faster rate under pulse stress than under DC stress. (c) Significant  $V_{TH}$  shift is observed in both the cases.

on device performance and reliability [1]. Change in device parameters was recorded from DC I-V characterization done at regular intervals during the stress routines, as discussed in Section II. Figure 7 presents a comparison of the change in ON-resistance ( $R_{ON}$ ), ON-current ( $I_{ON}$ ) and threshold voltage ( $V_{TH}$ ) under pulse and DC stress. Rapid and more severe changes in device parameters are observed under pulse stress compared to that in DC stress case. For instance, with only 100 pulses applied at drain,  $R_{ON}$  was found to increase by 25 %,  $I_{ON}$  dropped by 20 % and  $V_{TH}$  shift of 180 mV was recorded.

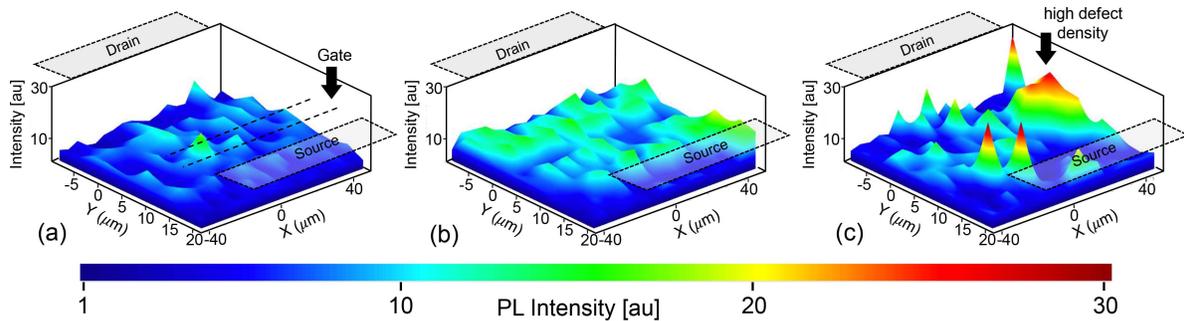
Fig. 8. PL intensity distribution for defect band (425-525 nm) captured between source-drain region of the HEMT device (a) before stress, (b) after stressing with 5000 pulses and (c) at the verge of failure.

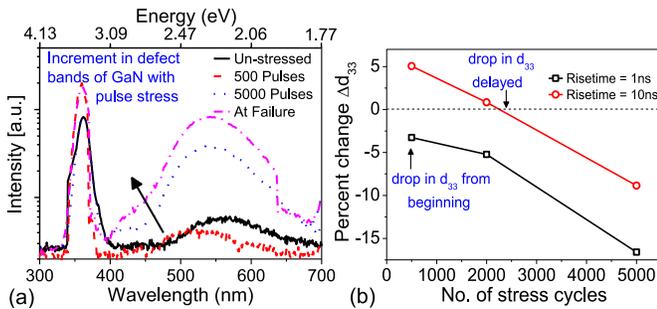
Fig. 9. (a) CL spectra of GaN captured in drain contact vicinity where highest PL intensity was observed. (b) Percentage change recorded in piezoelectric coefficient  $d_{33}$  with increasing number of stress cycles. Drop in  $d_{33}$  is delayed when pulse rise time is increased from 1 ns to 10 ns.

where,  $e_{33}$ ,  $e_{31}$  are piezoelectric coefficients and,  $C_{13}$ ,  $C_{33}$  elastic stiffness tensors. The generated strain creates new defects in bulk region, in drain contact vicinity, where peak field lies and accumulates with increasing number of stress pulses (Fig. 10b). Furthermore, the piezoelectric AlGaIn/GaN epi-stack undergoes cyclic loading via mechanical strain generation-relaxation, under pulse stress as evident from the Raman map, captured before and after pulse stress (Fig. 10a-b). Over the time, cyclic stress introduces changes in piezoelectric nature (Fig. 9b) and results in time dependent strain variation [16] as;

Such electrically developed fatigue under cyclic electrical loading, was observed in other piezoelectric materials too [17]. Furthermore, the electrical fatigue generated, keeps accumulating in device with each stress pulse, as evident from increased YL, BL bands in CL spectra (Fig. 9a) and increased hysteresis (Fig. 6) over time. Hence, electrical fatigue is accumulative in nature. Moreover, the GaN-buffer/AlGaIn-transition-region interface experiences maximum stress (Fig. 14a) under applied electric field. Over the time, the electrical fatigue nucleates micro-cracks at GaN-buffer/AlGaIn-transition-region interface (Fig. 11c). High strain energy at crack tip, under cyclic electrical loading, propagates it towards device top and hits the surface to form pits and causes catastrophic failure as seen in Fig. 11(a). On failure, abrupt increase in localized current density, melts drain contact metal and develops crack in top AlGaIn barrier due to thermal stress generated from the associated heating [10]. Then molten metal diffuses and migrates via crack [18]. Fatigue accumulation accelerates with rate of change of electric field (pulse rise time) possibly because the

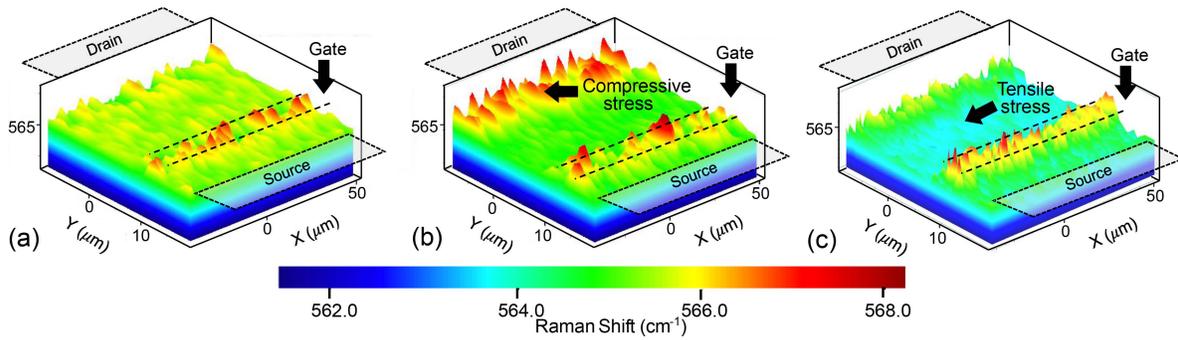
Fig. 10. (a) Raman map captured in region between source - drain in (a) pristine device (before stress) , (b) after application of 5000 stress pulses and (c) at the end of 2.5 hours of DC stress.

Defects generated under cyclic pulse stress in AlGaIn/GaN epi-stack layers. Electrically active defects or traps deteriorated the device performance as highlighted above. However, it is still not very clear, (i) where these trap levels are located within the GaN bandgap, (ii) how they are spatially distributed across the device and (iii) what is their temporal evolution under pulse stress. To understand these aspects, PL mapping of device's active region was done at regular intervals during the pulse stress routine. PL mapping of drain-source region revealed that the increased defect generation introduces deep level traps within defect band 425-525 nm ( $E_C - 0.48$  to  $E_C - 1.14$  eV). Also, the PL intensity, which is a direct measure of the trap density, was recorded as shown in Fig. 8. Pristine device exhibits a relatively uniform PL intensity distribution (Fig. 8a). PL intensity increases with number of stress pulses (Fig. 8b). However, it becomes non-uniform at the verge of failure with the highest PL intensity observed near the drain contact (which was under cyclic pulse stress) as in Fig. 8(c). Therefore, Fig. 8 reveals that the density of mid-bandgap defects (425-525 nm), increases with number of pulses with peak concentration close to the drain contact edge. CL spectra is taken at the location of highest PL intensity near the drain, after different number of stress pulses as shown in Fig. 9(a). It shows an increase in Blue (BL) and Yellow luminescence (YL) intensities with stress pulses which confirms the presence of mid-bandgap defects. CL profiling reveals penetration depth of  $\sim 1.2 \mu\text{m}$  from top surface [12]. Hence, it is confirmed that these mid-bandgap defects are located in GaN buffer,  $1.2 \mu\text{m}$  below the device surface near the drain contact. Raman map is captured between source-drain region of the device before and after the stress routines as in Fig. 10. A residual stress is observed in the recessed region under gate

in pristine device (before stress) as seen in Fig. 10(a). A significant compressive stress builds up at the drain contact edge after the device is stressed with 5000 pulse cycles as shown in Fig. 10(b) and it is different from the strain distribution obtained under DC stress condition, as evident from Fig. 10(c). The stress signature received, is from the GaN buffer which correlates well with penetration depth ( $1.2 \mu\text{m}$ ) determined from CL measurements.

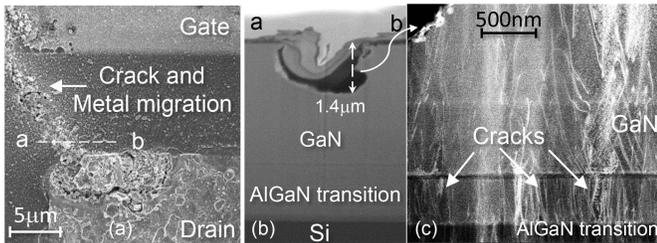
Fig. 11. (a) Top view SEM image depicting HEMT failure under 600 V drain-to-substrate pulse stress. (b) Cross-sectional SEM taken along line 'a-b' in (a). (c) HR-TEM image of the region below the damaged area in (b).

Strain accumulation in GaN buffer region underneath drain contact can possibly be a manifestation of physical change in material quality and nature. To verify this, the piezoelectric coefficient ( $d_{33}$ ) which is responsible for biaxial strain in AlGaIn/GaN stack, is spot measured after a fixed number of stress cycles. The measurement is done across twenty five equally spaced points along the device width near the drain end, using Piezo-response Force Microscopy (PMF). Figure 9(b) shows percentage change in  $d_{33}$  as recorded, with increasing number of stress cycles. Device stressed with 1 ns rise time pulse, suffered early drop in  $d_{33}$ , however increase in rise time to 10 ns delayed the degradation in  $d_{33}$ . This observation indicates, that the very fundamental piezoelectric nature of AlGaIn/GaN epi-stack changes under pulse stress. However, what triggered the change in piezo-coefficients in AlGaIn/GaN epi-stack? To understand the root cause, failure analysis of damaged regions of devices was done. Figure 11 shows the post failure SEM images of a device which catastrophically failed within 100 pulses of 600 V each. Top view SEM image of failed device reveals failure occurred with massive crack in the gate-drain region (Fig. 11a). Cross-sectional SEM is done along the line 'a-b' at the damaged drain edge and is shown in Fig. 11(b).

It reveals that the damage reaches  $1.4 \mu\text{m}$  deep into the GaN buffer. The region underneath the damage is scanned using a high resolution-TEM. The HR-TEM image of the region is shown in Fig. 11(c). It depicts presence of multiple cracks at the interface of GaN-buffer/AlGaIn-transition-region, just below the damaged region. On the other hand, in the devices which failed under DC stress, no failure signature is observed in the bulk and the damage is localized to the device surface as depicted in Fig. 12(a)-(b). TEM cross-section of damaged region taken along line 'a-b' (Fig. 12c) reveals a network of dislocations with no visible damage in epi-stack. Dislocations are intrinsic to AlGaIn/GaN stack grown on foreign substrate and are present in pristine (unstressed) device as well. Figure 13 shows TEM image of buffer region of a pristine device. From these observations it can be concluded that the failure under DC stress occurred due to dislocations which act as current leakage path [5].

0.01 eV/Å force tolerance and 0.001 eV/Å<sup>3</sup> stress tolerance. Local Density Approximation (LDA) exchange-correlation function is used to improve computational efficiency with 10x10x1 k point sampling and density mesh cut-off of 45 Hartree. Electric field was applied across GaN/AlN normal to the interface plane in the module as shown in Fig. 14(a) top. The DFT computation results presented in Fig. 14(a) show the distribution of normal component of electric field;  $E_z$  (left y-axis) and change in total force;  $\Delta F$  (right y-axis) experienced by individual *Ga*, *Al* and *N* atoms within the GaN/AlN system. The periodic fluctuation in electric field/force as seen in bulk of GaN and AlN, originates from the periodic potential of *Ga*, *Al* and *N* atom arrangement along c-axis of the crystal.  $\Delta F$  varies from GaN to AlN with maximum change at the GaN/AlN interface. The maximum increment in force occurs at the interface as the electric field component peaks close to the interface. Therefore, the GaN/AlN interface undergoes maximum stress (force per unit area) during pulse switching and eventually it develops micro-cracks (Fig. 11c).

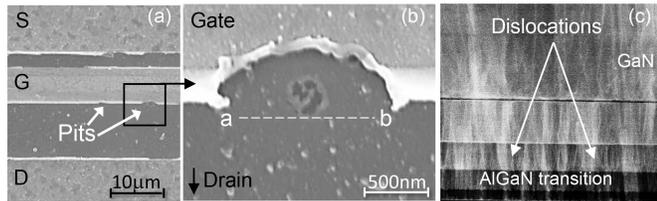
Fig. 12. (a)-(b) Top view SEM images of HEMT device failed after 600 V of DC stress. (c) Cross-sectional TEM along line 'a-b' in (b).

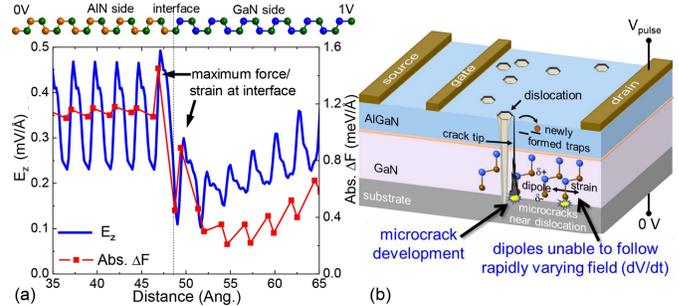
Fig. 14. (a) Simulated electric field and change in total force, experienced by individual atoms in GaN/AlIn system under 1 V stress applied on GaN side. (b) Schematic illustrating the failure physics under pulse transient stress.

intrinsic dipoles are unable to follow the rapidly changing field and get strained and assist in micro-crack development as illustrated in Fig. 14(b). This results in drop in TTF for faster cyclic transients (Fig. 4b). It should be noted that the proposed failure model is applicable only for time dependent failure of AlGaIn/GaN epi-stack under pulse transient stress.

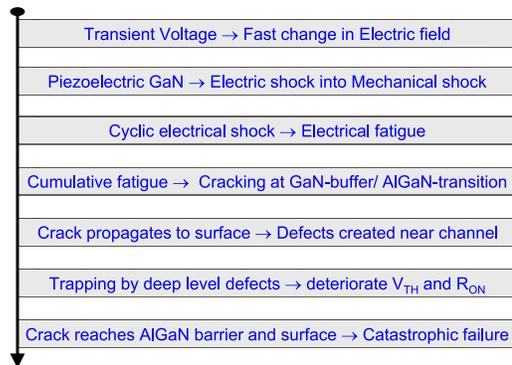
Fig. 15. Sequence of events involved in time dependent breakdown of AlGaIn epi-stack and shift in SOA boundary of HEMT, under fast cyclic pulse stress.

Figure 15 presents a sequence of events which constitute the proposed failure model of AlGaIn/GaN epi-stack under

pulse transient stress. As discussed above, the electrical cyclic loading under pulse condition, causes stress accumulation and defect generation via compressive piezoelectric strain in GaN buffer and transition region. To validate the proposed argument, a device was stressed with 5000 pulse cycles at drain before its Raman map was captured. A significant compressive stress gets accumulated around drain contact (Fig. 16a). Subsequently, the stressed device is heated at 373K for 10 mins followed by Raman mapping. Raman profile depicts that after heating, the compressive stress at drain relaxes (Fig. 16b). Heating in device introduces thermoelastic tensile stress which partially compensates compressive stress [19]. This improvement should be reflected in TTF of AlGaIn/GaN epi-stack. To verify this, GaN epi-stack is pulse stressed at 373K and

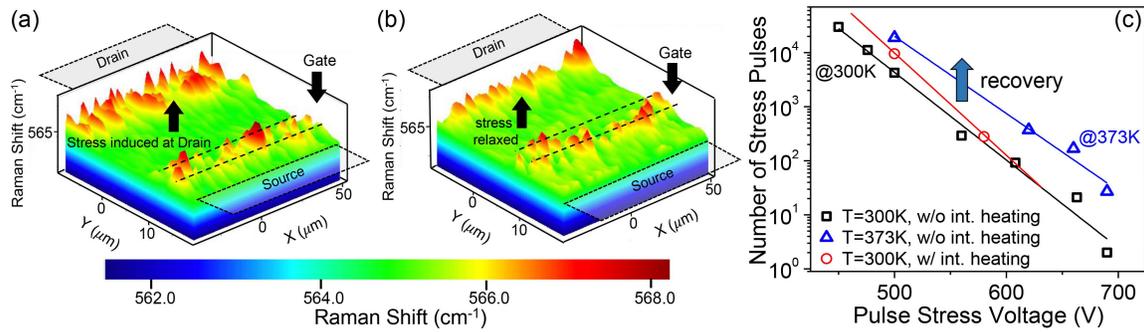
Fig. 16. (a) Raman map of device after it is stressed with 5000 pulses (b) Raman map captured, after the device was heated at 373K post pulse stress. (c) Variation in TTF of AlGaIn/GaN epi-stack under pulse stress, recorded at different temperature treatment. Heating improves TTF.

its TTF is extracted. In another experiment, AlGaIn/GaN epi-stack is pulse stressed and intermediate heat treatment (373K) is given to it. Figure 16(c) shows the TTF of AlGaIn/GaN epi-stack extracted at different temperature under pulses stress. TTF improved with heat treatment (Fig. 16c), which validates the proposed failure model.
