Time Dependent Early Breakdown of AlGaIn/GaN Epi Stacks and Shift in SOA Boundary of HEMTs Under Fast Cyclic Transient Stress

Bhawani Shankar¹, Ankit Soni¹, Sayak Dutta Gupta¹, Swati Shikha¹, Sandeep Singh¹,
Srinivasan Raghavan² and Mayank Shrivastava¹

¹Department of Electronic Systems Engineering and ²Center for Nanoscience and Engineering,
Indian Institute of Science, Bangalore, India, email: mayank@iisc.ac.in

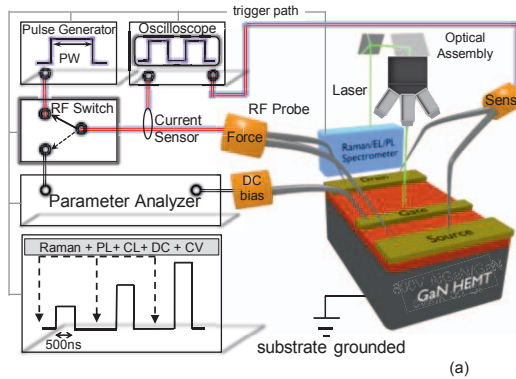
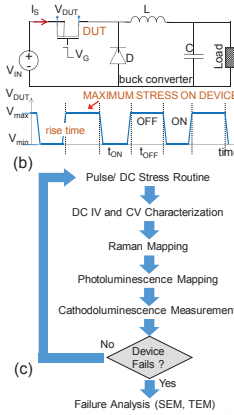
Fig. 4. (a) Schematic of experimental setup with integrated Raman, PL and sub- μ s pulse generator used for on-the-fly electrical and material characterization of HEMT/Epi-Stack under dc and pulse stress conditions. Electrical stress routine (dc and pulse) was interrupted at regular intervals, to record, evolution of mechanical stress profile using visible Raman ($\lambda=532\text{nm}$) and defects density distribution using UV-PL ($\lambda=325\text{nm}$) across the active region. CL spectra was also captured in gate-drain region at different stress time. Inter-pulse dc IV and CV characterization was also done to record variation in device parameters with stress time. (b) Schematic representation of a buck power converter showing device voltage (V_{DUT}) waveform during switching. Maximum voltage stress appears across the device during the OFF-cycle of the converter. Hence, pulse stress degrades the device performance with each cycle.

Hence device's safe operating area shrinks over time under switching operation. (c) The flowchart represents the sequence of various types of device and material characterizations performed during pulse and dc stress routines.
