First Observations on the Trap-Induced Avalanche Instability and Safe Operating Area Concerns in AlGaN/GaN HEMTs

Bhawani Shankar[®], Ankit Soni[®], Hareesh Chandrasekar[®], Srinivasan Raghavan, and Mayank Shrivastava[®], *Senior Member, IEEE*

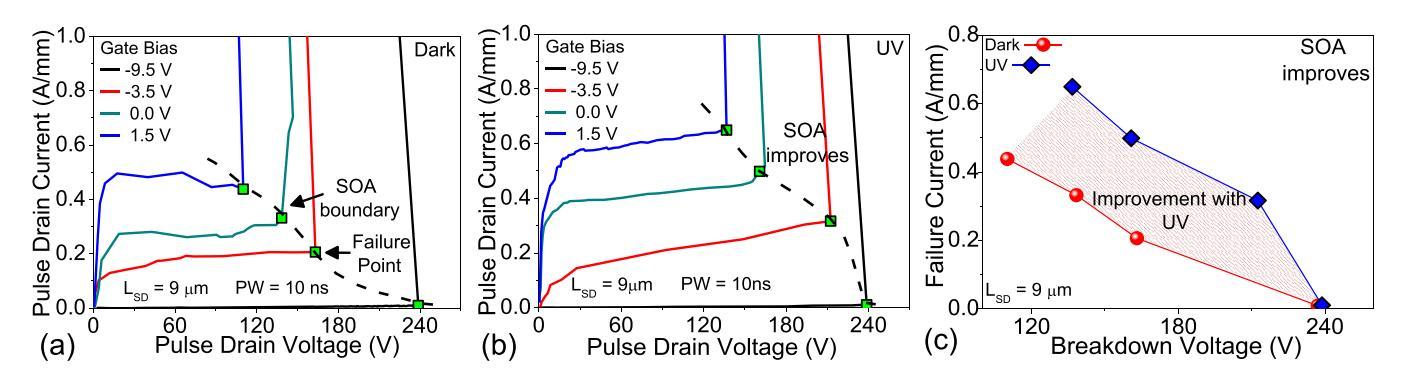
Fig. 1. Pulse *I–V* characteristics of HEMT (a) under dark condition and (b) with UV exposure. Failure point shown here marks the SOA boundary. (c) Variation in SOA boundary of HEMT stressed under dark and UV condition. As evident, SOA boundary of device widens under UV light.

A device (L_{SD} 9 μ m) is tested at 10-ns PW, under dark and in UV light condition. Corresponding pulse I-V characteristics are shown in Fig. 1. As shown in the figure, the device breakdown is marked with an abrupt increase in pulse drain current at the failure point. The locus of the failure point over the entire family of curves marks the SOA boundary of the device. A comparison of I-V characteristics obtained under dark and UV, shown in Fig. 1 unveils the following: 1) early saturation in drain current and 2) early device failure when tested under dark. As a result, the SOA shrinks under dark condition. When the experiment is repeated under UV light, no current collapse is shown and the drain current exhibits quasi-saturation behavior as depicted in Fig. 1(b). The device fails at higher voltage and current, exhibiting broader SOA. Fig. 1(c) shows the comparison of the SOA boundary of a device extracted under dark and UV. As evident, SOA boundary widens under UV light. Under normal device operation, excessive carrier trapping in gate-drain region causes drain current collapse [9]. Trapping underneath the gate can alter threshold voltage [7], while trapping at AlGaN/GaN interface [10] and in buffer increases R_{ON} [11]. Trap-induced effects degrade device performance, and carrier trapping further increases after degradation [10]. This positive feedback loop continues until the device sees catastrophic breakdown, which is discussed in the next section. The exposure of subbandgap UV light potentially detraps carriers from shallow and deep defect levels present in different regions of the device. Therefore, UV light suppresses trap-induced degradation in the device and improves device SOA. To summarize, the SOA boundary of GaN HEMT is limited under normal operating condition and it gets recovered with subbandgap UV exposure.

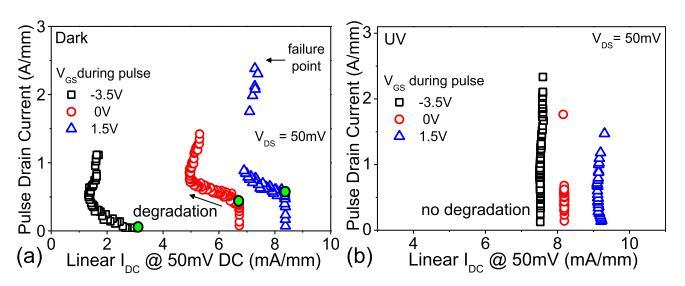
Fig. 3. (a) Linear drain-to-source current measured after each stress pulse of 100-ns duration applied at drain of a device of L_{SD} 7 μ m under (a) dark and (b) UV condition. Unique current degradation trend can be observed under dark condition at different gate biases, which is absent under UV illumination.

applied at drain (V_P) . Fig. 3(a) shows the degradation trend in I_{dc} observed under dark condition for different gate biases. It shows that at negative gate voltage (here -3.5 V), when the device is under pinched-off condition, device degradation initiates (as marked by green dot) at lower stress voltages/currents. On the other hand, at under ON-state ($V_{GS} = 0$ and 1.5 V), the onset of device degradation (as marked by green dot) was pushed to higher voltages/currents. This shows the requirement of a critical field in gate-drain region for the device to degrade. With increasing drain stress voltage, the electric field in gatedrain region increases which enhances electron injection from gate to surface and channel to GaN buffer. This reduces 2DEG density to obey vertical charge neutrality and results in a drop in drain current. It should be noted that SOA measurements demands application of ultrahigh voltage, short duration (sub-200 ns) pulses between drain-source terminals of GaN HEMT, under ON-and OFF-states, which would eventually lead to HEMT's failure. At these high voltages, the device would lead to excess hot electron generation via impact ionization (II), which rapidly increases the drain-to-source current beyond typical HEMT's drain current (~ 1 A/mm). Since the stress pulse duration is in the sub-200-ns range, the electron-phonon scattering due to self-heating or increased phonon population, which can lower the carrier energy and bring the current back to the nominal range (~ 1 A/mm) is largely missing. This behavior explains very high drain current shown in Figs. 3 and 11, which are extracted using pulses applied for 100 ns or lower. Moreover, the excess carrier holes generated from II can potentially deteriorate the gate control, as discussed in the subsequent sections. Furthermore, under ON-state with increased drain voltage, the hot electron density in channel increases. Hot electrons activate traps at AlGaN/GaN interface [12] and further deteriorates I_{dc} . When the same experiment was performed under UV condition, no degradation in device's dc behavior was observed, independent of gate voltage, as depicted in Fig. 3(b). This hints the role of trap states in device degradation. It is worth highlighting, before explaining these trends further, that UV irradiation is expected to detrap all the captured electrons from the deep acceptor trap levels. It is to be noted that a delay of 200 ms is introduced between two consecutive pulses. However, the slow detrapping from deep levels can take several seconds to hours for recovery. In the present case, as I_{dc} degrades monotonically under the dark condition with each pulse, it can be concluded

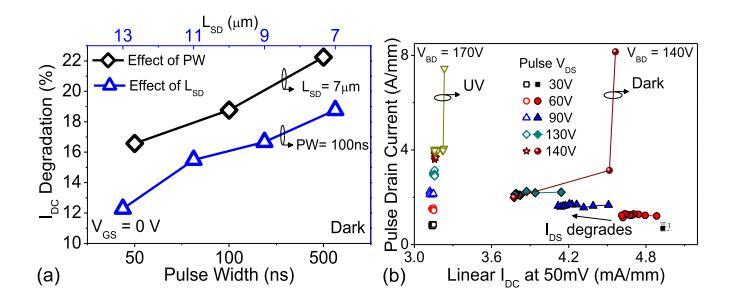
Fig. 4. (a) Degradation in linear drain current measured under dark condition as a function of PW and source-to-drain spacing. (b) Cumulative degradation extracted by applying set of ten constant voltage pulses at drain before increasing its amplitude. A cumulative degradation is visible under dark condition, which is missing in the presence of UV light.

The degradation trends discussed above can be explained as follows: at higher drain stress, hot electrons in channel generate new defects and get trapped at the surface, in barrier and buffer regions. This is responsible for the degradation in device performance. With UV exposure, carrier detrapping gets enhanced which assists in suppressing the trap originated device degradation. Stress experiments done at different PWs show that degradation increases linearly with PW, due to longer stress time available for carrier trapping. Furthermore, percentage degradation is extracted for devices with different source-to-drain spacings which are tested under the same pulse condition (100 ns). Percentage degradation is found to decrease linearly with L_{SD} , as shown in Fig. 4(a), which is attributed to the reduced channel field at larger L_{SD} .

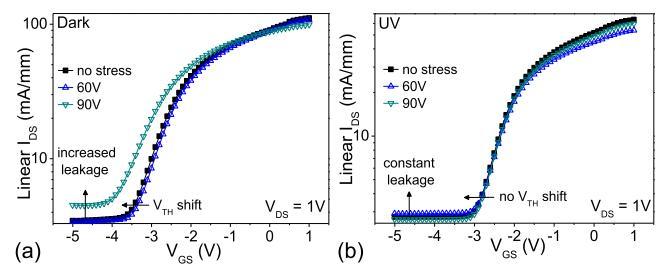
Fig. 5. (a) DC transfer characteristics measured after stressing device using a set of ten pulses under dark and (b) UV conditions. In dark condition, device's OFF-state leakage increases and threshold voltage changes, which is absent in the presence of UV exposure.

DC I - Vcharacterization of devices-under-stress is performed at regular intervals during the test to record the changes in device's characteristics and parameters such as $V_{\rm TH}$, drain-source leakage, $R_{\rm ON}$, and $I_{\rm SAT}$. Fig. 5 shows the dc transfer characteristic of a device stressed using 100-ns wide pulses, under dark and UV conditions. As depicted in Fig. 5(a), stress under dark introduces: 1) V_{TH} shift and 2) increases drain-source leakage. Observed negative shift in $V_{\rm TH}$ reveals positive charge accumulation underneath gate [6] and modified Schottky barrier height due to the increased interface defects [13] with stress. The increased OFF-state leakage results from: 1) reduced V_{TH} [7]; 2) increased buffer leakage [14]; and 3) degraded gate-drain Schottky diode [15]. This degradation can be explained using electron trapping in acceptor states present in GaN buffer, as the same was found to recover with UV light as shown in Fig. 5(b), where the transfer characteristic remain unchanged with stress. To validate this argument, TCAD simulations were performed using setup explain in our earlier works [16]-[18]. Here, donor-type surface trap $(E_C - 0.6 \text{ eV})$ is considered uniformly distributed over the GaN cap surface. Acceptortype buffer traps $(E_C - 2.1 \text{ eV})$ are included with Gaussian distribution with peak density at AlGaN/AlN interface. Fig. 6(a) and (b) shows the redistribution of e-field as the acceptor trap concentration is increased. Electric field both at the surface and the channel was found to shift toward the drain edge when buffer trap concentration was increased. This shift in peak field from gate-to-drain edge enhances II at drain end and causes early device breakdown as discussed next.

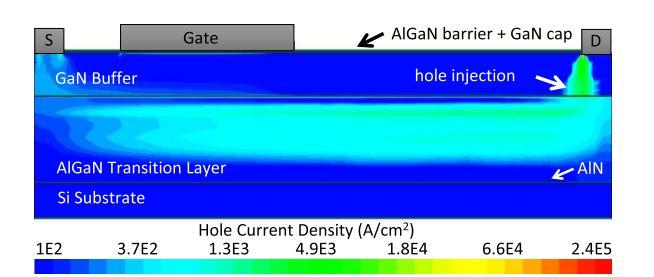
Fig. 8. TCAD contour depicting hole distribution in the device at OFF-state breakdown. Excess holes generated near drain inject into buffer and form parasitic S/D short path in buffer.

electric field. Eventually, it triggers avalanche [20] forming a highly conducting narrow parasitic hole path or filament as shown in Fig. 8. To experimentally verify the explanation, two Ohmic contacts (marked A, B) are realized on either side of a HEMT device, as shown in Fig. 9(b). Contact-A and B are isolated by a 200-nm-deep MESA isolation on either side of main HEMT so that only buffer current flows through them. While stressing the main HEMT, the buffer current between contact-A and B is monitored over the time. The buffer current abruptly increases by 600 times on the verge of failure, as shown in Fig. 9(c) which marks the formation of filament (Fig. 8) and causes permanent device failure. Postfailure analysis, which is discussed in the next section, corroborates well with the TCAD-based findings.

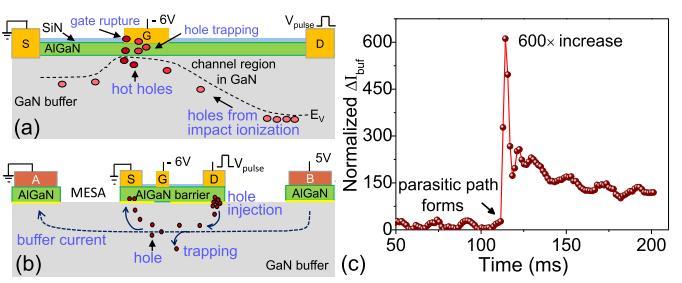
Fig. 9. (a) Device schematic presenting the device failure mechanism under dark condition. Here, GaN cap is not shown for simplicity. (b) Test structure with HEMT device and Ohmic probe contacts (A, B), used to monitor variation in buffer current during OFF-state stress. (c) Change in buffer current measured using test structure in (b) during the OFF-state stress.

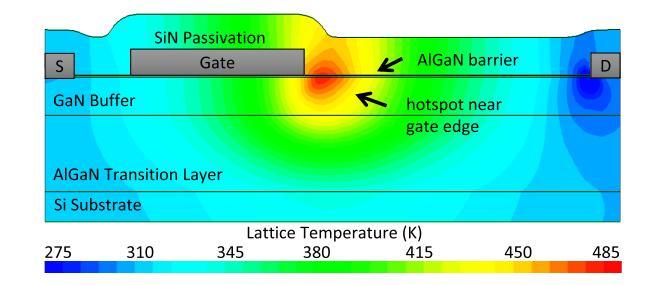
Fig. 10. TCAD contour depicting temperature distribution across the device at device breakdown. Hotspot can be seen near drain side gate edge.

at gate edge toward drain. At high drain voltage, enhanced current density (J) and peak electric field (E) at gate edge forms a hotspot (J.E) as depicted from temperature distribution shown across the device in Fig. 10, extracted at breakdown. Failure analysis presented in the later sections for a device which failed under UV, reveals damage at the gate edge, which corroborates well with the failure physics investigated using TCAD simulations.

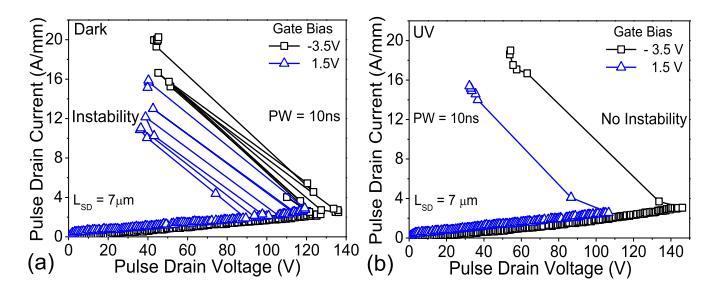
Fig. 11. (a) Snapback instability observed in I-V characteristics extracted under dark conditions using 10-ns-wide PW. (b) Snapback instability absent in the presence of UV exposure.

When devices are stressed using shorter pulses (PW = 10 ns), an unstable snapback region is observed in the *I*–V characteristics beyond the breakdown point, under dark condition. That is, each time the device enters the snapback mode, which is a state before filamentary failure, it recovers back repeatedly, as depicted in Fig. 11(a). However, when the same test is repeated under UV light, the instability vanishes and the device sees clear failure, at higher voltage, as shown in Fig. 11(b). This hints that the observed instability is related to carrier trapping, which is explained as follows: across the wafer and, hence, along the device width, there is always a finite variation in defect density and spatial stress distribution, originating from the MOCVD growth of GaN/AlGaN. Due to this, trap generation and carrier trapping occur nonuniformly across the device width. This leads to the formation of localized regions, where carrier trapping is higher compared to the rest of the device's active region. Such regions with high trap density, in turn, experience an early shift in electric field peak toward drain, as shown in Fig. 6. This results in the formation of the localized parasitic path(s) as shown in Fig. 8. These localized parasitic paths

lead to the formation of multiple current filaments along the device width. Beside failure analysis results discussed in the next session, the avalanche instability due to filament formation can be validated from pulse-to-pulse instability observed in Fig. 11(a), when measured under dark condition. In this case, the device forms a filament, however; it survives failure due to the short duration of applied stress. As a result, the device tries to enter into snapback state multiple times, before experiencing a localized thermal failure at higher currents. However, the same instability is absent under UV exposure as shown in Fig. 11(b). This confirms the role of traps in inducing avalanche instability in AlGaN/GaN HEMT.
